**Flood Control Project Maintenance
Levee Inspections**

Maintenance Issue Types Only, Levee Inspection Report By Mile - Spring 2016

San Joaquin County Flood Control and Water Conservation District

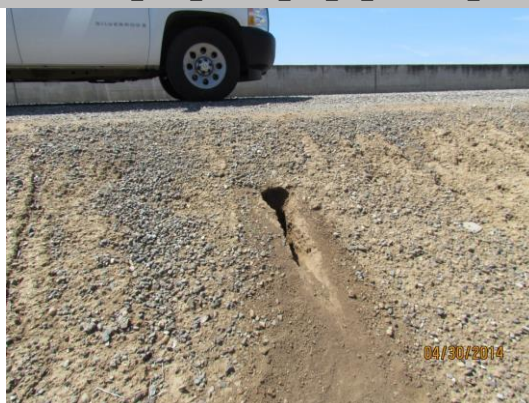
Photo 2 of 2 : SP_2016_NA0017_159_32_20160219_00049.jpg

A rodent hole was found on the landside of the levee looking downstream.

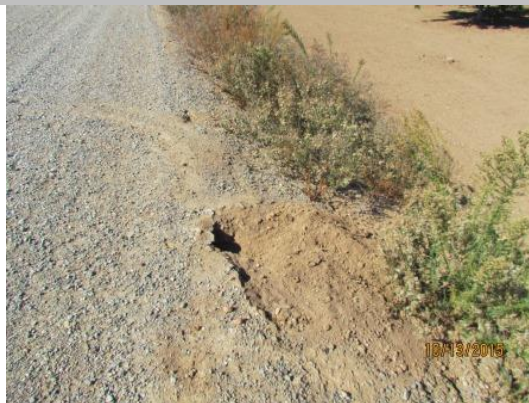
Photo 1 of 2 : SP_2016_NA0017_159_71_20160219_00081.jpg

LM Start	15.43	Rating **	M	Issue No.	71
LM End	15.43	Issue Type +	Ma	Location *	LS
Category	Earthen Levee			GPS Latitude/Longitude	
				Start	End
Item	Animal Control			37.976000 °	37.976000 °
				-121.235156 °	-121.235156 °
DWR ID	DWR_NA0017_15_s_2013_71				
Comment Code					
A3 : No rodents visible, but rodent burrows visible; need to backfill and compact or grout burrows.					
Inspector Comment

Updated picture of the rodent holes on the landside of the levee looking downstream during fall 2015 inspection.

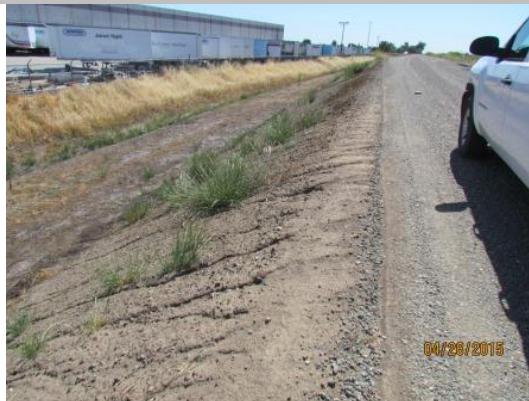
Photo 1 of 1 : SP_2016_NA0017_159_198_20160219_00142.jpg

LM Start	16.14	Rating **	M	Issue No.	198
LM End	16.14	Issue Type +	Ma	Location *	LS
Category	Earthen Levee			GPS Latitude/Longitude	
				Start	End
Item	Slope Stability			37.980961 °	37.980961 °
				-121.246553 °	-121.246553 °
DWR ID	DWR_NA0017_15_s_2015_198				
Comment Code					
S1 : Repair slope instability.					
Inspector Comment					
Runoff

View of slope instability due to runoff on the landside of the levee looking upstream.

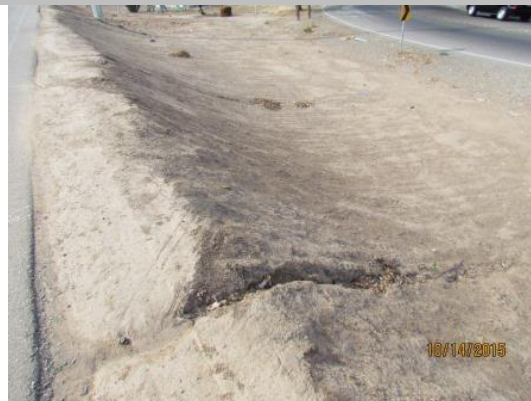
Photo 1 of 1 : SP_2016_NA0017_159_172_20160219_00131.jpg

LM Start	21.25	Rating **	M	Issue No.	172
LM End	21.25	Issue Type +	Ma	Location *	LS
Category	Earthen Levee			GPS Latitude/Longitude	
				Start	End
Item	Erosion / Bank Caving			37.988969 °	37.988969 °
				-121.307009 °	-121.307009 °
DWR ID	DWR_NA0017_15_f_2015_172				
Comment Code					
E2 : Schedule repair of erosion site prior to the next inspection.					
Inspector Comment					
Runoff.

Erosion was found on the landside of the levee looking downstream.

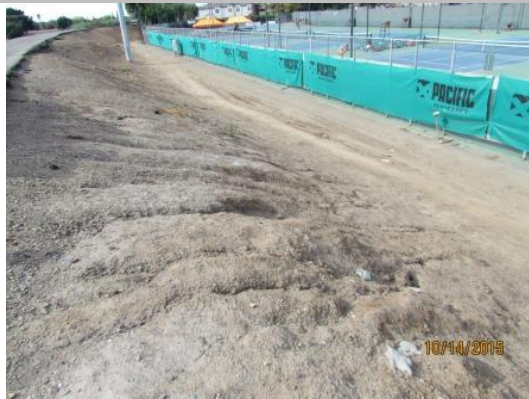
Photo 1 of 1 : SP_2016_NA0017_159_173_20160219_00132.jpg

LM Start	21.96	Rating **	M	Issue No.	173
LM End	21.96	Issue Type +	Ma	Location *	LS
Category	Earthen Levee			GPS Latitude/Longitude	
				Start	End
Item	Erosion / Bank Caving			37.981147 °	37.981147 °
				-121.315071 °	-121.315071 °
DWR ID	DWR_NA0017_15_s_2012_173				
Comment Code					
E2 : Schedule repair of erosion site prior to the next inspection.					
Inspector Comment					
Runoff.

View of the erosion caused by run off on the landside slope of the levee looking downstream during fall 2015 inspection.

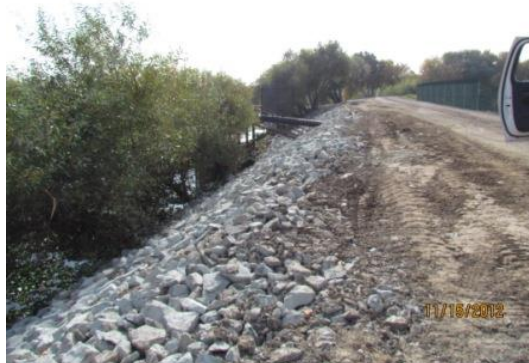
Photo 1 of 1 : SP_2016_NA0017_159_187_20160219_00138.jpg

LM Start	24.00	Rating **	A/W	Issue No.	187
LM End	24.00	Issue Type +	Ma	Location *	WS
Category	Earthen Levee			GPS Latitude/Longitude	
				Start	End
Item	Riprap Revetments			37.974858 °	37.974858 °
				-121.347718 °	-121.347718 °
DWR ID	DWR_NA0017_15_f_2012_187				
Comment Code					
Inspector Comment

Revetment was placed by the LMA on the waterside slope of the levee looking downstream.

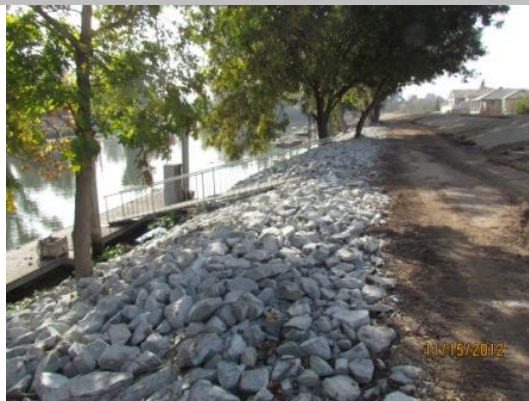
Photo 1 of 1 : SP_2016_NA0017_159_188_20160219_00139.jpg

LM Start	24.65	Rating **	A/W	Issue No.	188
LM End	24.65	Issue Type +	Ma	Location *	WS
Category	Earthen Levee			GPS Latitude/Longitude	
				Start	End
Item	Riprap Revetments			37.969095 °	37.969095 °
				-121.356301 °	-121.356301 °
DWR ID	DWR_NA0017_15_f_2012_188				
Comment Code					
Inspector Comment

Revetments were placed by the LMA on the waterside slope of the levee looking downstream.

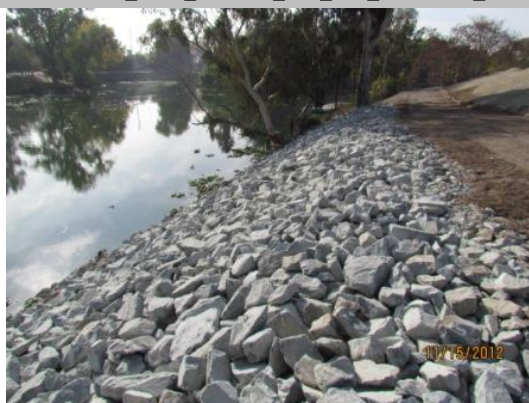
Photo 1 of 1 : SP_2016_NA0017_159_189_20160219_00140.jpg

LM Start	24.81	Rating **	A/W	Issue No.	189
LM End	24.81	Issue Type +	Ma	Location *	WS
Category	Earthen Levee			GPS Latitude/Longitude	
				Start	End
Item	Riprap Revetments			37.967943 °	37.967943 °
				-121.358711 °	-121.358711 °
DWR ID	DWR_NA0017_15_f_2012_189				
Comment Code					
Inspector Comment

Revetments were placed by the LMA on the waterside slope of the levee looking downstream.

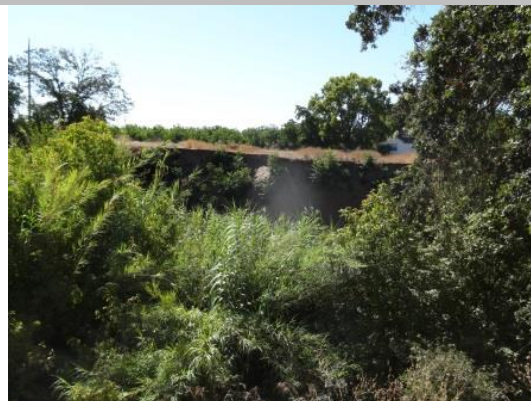
Photo 2 of 3 : SP_2016_NA0017_160_82_20160219_00077.jpg

LM Start	0.11	Rating **	U	Issue No.	82 (cont)
LM End	0.47	Issue Type +	Ma	Location *	WS
Category	Supplemental			GPS Latitude/Longitude	
				Start	End
Item	DWR Erosion Survey			38.048159 °	38.048159 °
				-121.016427 °	-121.016427 °
DWR ID	DWR_NA0017_16_s _ 2016_82				
Comment Code					
Inspector Comment					
8/12/2015: The erosion progressed at the site. Newly collapsed material is observed at the bottom of the erosion.					
8/20/2014: The erosion at the site has worsened. The erosion increased in both length and in height.					
09/12/2013: Site has been visited and signs of new erosion are visible.					
08/22/2012: The erosion was surveyed and documented for monitoring purpose. There is no levee structure on the site, only high ground protecting the land behind. The levee crest width and levee height were not measured or estimated in the field. [2015 Site ID:NA0017U16RM23.35]

Front view of the erosion. Looking from the right side of the river.

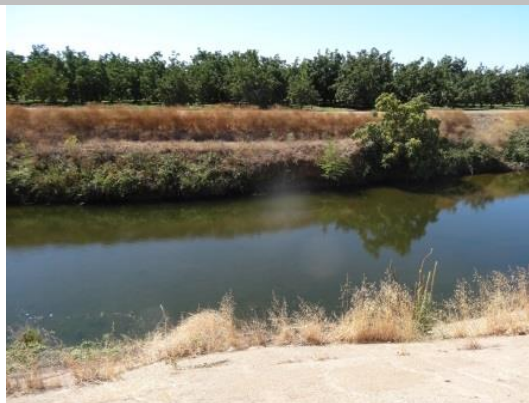
Photo 1 of 3 : SP_2016_NA0017_160_76_20160219_00071.jpg

LM Start	1.75	Rating **	M	Issue No.	76
LM End	1.76	Issue Type +	Ma	Location *	WS
Category	Supplemental			GPS Latitude/Longitude	
				Start	End
Item	DWR Erosion Survey			38.038080 °	38.038080 °
				-121.038676 °	-121.038676 °
DWR ID	DWR_NA0017_16_s_2016_76				
Comment Code					
Inspector Comment					
8/12/2015: No significant change observed.					
8/20/2014: No significant change observed.					
9/12/2013: No significant change observed.					
08/22/2012: The erosion is covered by dense vegetation. There is no levee structure on site. The levee crest width and levee height were not measured or estimated in the field. [2015 Site ID:NA0017U16RM21.95]

Front view of the erosion site.

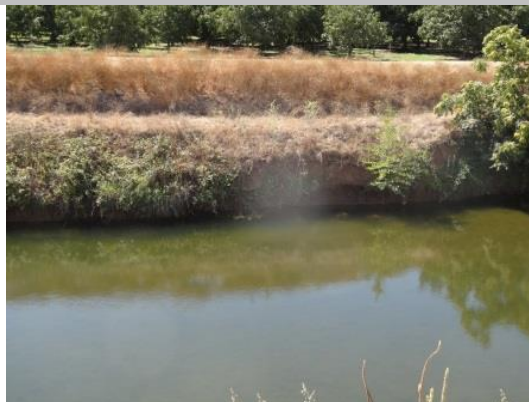
Photo 2 of 3 : SP_2016_NA0017_160_76_20160219_00072.jpg

Close view of the erosion.

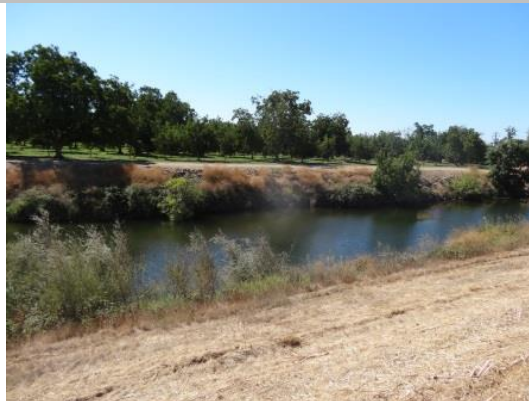
Photo 1 of 3 : SP_2016_NA0017_160_70_20160219_00063.jpg

Front view of the site.

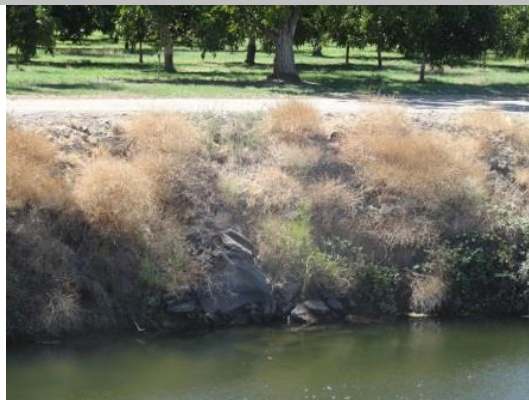
Photo 2 of 3 : SP_2016_NA0017_160_70_20160219_00064.jpg

Close view of the erosion. Note the vegetation at the site.

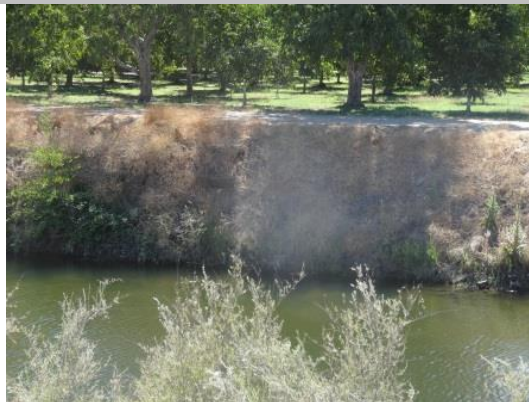
Photo 3 of 3 : SP_2016_NA0017_160_70_20160219_00065.jpg

Close view of the site.

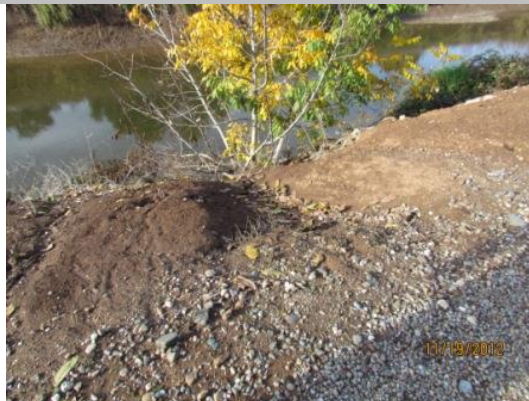
Photo 1 of 2 : SP_2016_NA0017_160_213_20160219_00134.jpg

LM Start	2.35	Rating **	M	Issue No.	213
LM End	2.35	Issue Type +	Ma	Location *	WS
Category	Earthen Levee			GPS Latitude/Longitude	
				Start	End
Item	Slope Stability			38.031763 °	38.031763 °
				-121.045808 °	-121.045808 °
DWR ID	DWR_NA0017_16_f_2012_213				
Comment Code					
S1 : Repair slope instability.					
Inspector Comment

Updated picture of the slope instability on the waterside shoulder of the levee looking upstream.

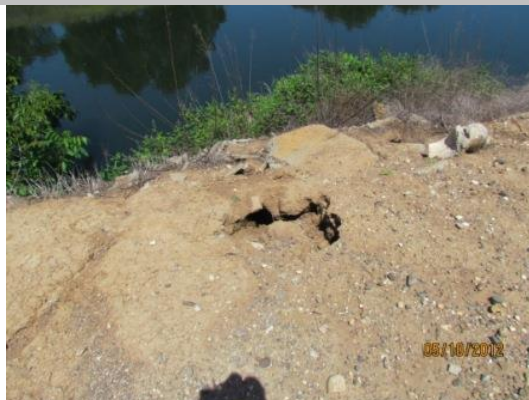
Photo 2 of 2 : SP_2016_NA0017_160_213_20160219_00135.jpg

Slope instability was found on the waterside of the levee looking upstream.

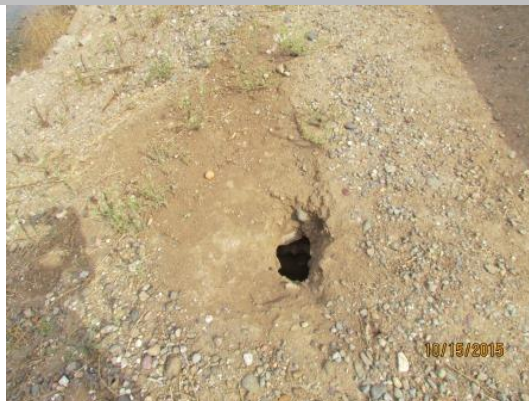
Photo 1 of 1 : SP_2016_NA0017_160_233_20160219_00141.jpg

LM Start	2.36	Rating **	M	Issue No.	233
LM End	2.36	Issue Type +	Ma	Location *	WS
Category	Earthen Levee			GPS Latitude/Longitude	
				Start	End
Item	Animal Control			38.031654 °	38.031654 °
				-121.045925 °	-121.045925 °
DWR ID	DWR_NA0017_16_f_2015_233				
Comment Code					
A3 : No rodents visible, but rodent burrows visible; need to backfill and compact or grout burrows.					
Inspector Comment

A rodent hole was found on the waterside of the levee.

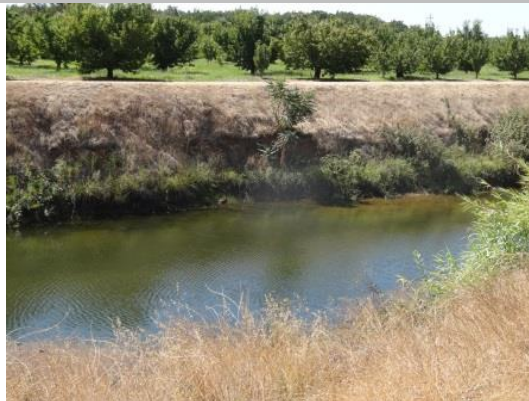
Photo 1 of 4 : SP_2016_NA0017_160_64_20160219_00054.jpg

LM Start	2.85	Rating **	U	Issue No.	64
LM End	2.91	Issue Type +	Ma	Location *	WS
Category	Supplemental			GPS Latitude/Longitude	
				Start	End
Item	DWR Erosion Survey			38.026670 °	38.026670 °
				-121.053031 °	-121.053031 °
DWR ID	DWR_NA0017_16_s _ 2016_64				
Comment Code					
Inspector Comment					
8/12/2015: No significant change observed.					
8/20/2014: No significant change observed.					
9/12/2013: No significant change observed.					
08/22/2012: Site Comprised of series of pocket and scarp erosions.					
Some of erosions are covered by grass or shrubs. There is no levee					
structure on site. The levee crest width and levee height were not					
measured or estimated in the field. [2015 Site ID:NA0017U16RM20]

Front view of the erosion.

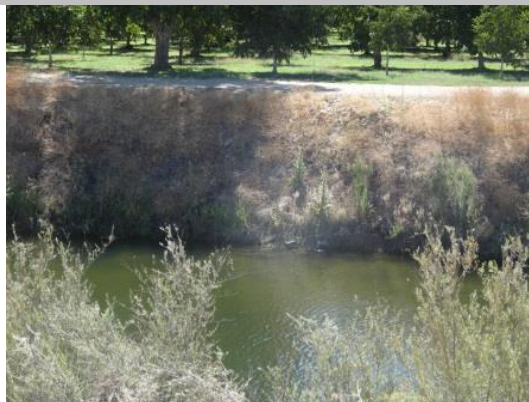
Photo 2 of 4 : SP_2016_NA0017_160_64_20160219_00055.jpg

Close view of the erosion.

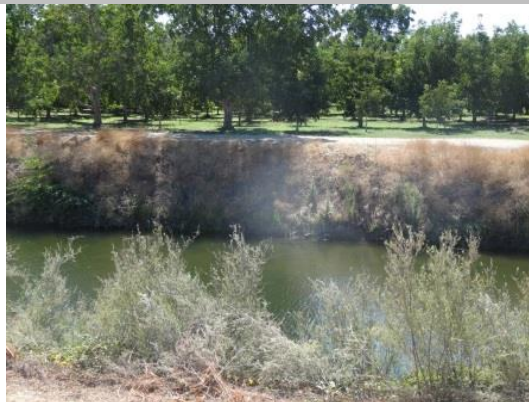
Photo 3 of 4 : SP_2016_NA0017_160_64_20160219_00056.jpg

Front view of the erosion.

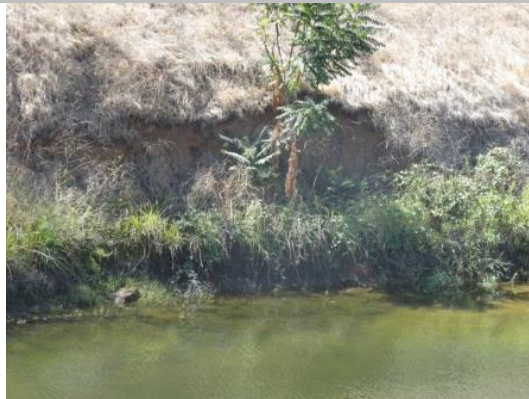
Photo 4 of 4 : SP_2016_NA0017_160_64_20160219_00057.jpg

LM Start	2.85	Rating **	U	Issue No.	64 (cont)	
LM End	2.91	Issue Type +	Ma	Location *	WS	
Category	Supplemental			GPS Latitude/Longitude		
				Start	End	
Item	DWR Erosion Survey			38.026670 °	38.026670 °	
				-121.053031 °	-121.053031 °	
DWR ID	DWR_NA0017_16_s _ 2016_64					
Comment Code						
Inspector Comment						
8/12/2015: No significant change observed.						
8/20/2014: No significant change observed.						
9/12/2013: No significant change observed.						
08/22/2012: Site Comprised of series of pocket and scarp erosions.						
Some of erosions are covered by grass or shrubs. There is no levee						
structure on site. The levee crest width and levee height were not						
measured or estimated in the field. [2015 Site ID:NA0017U16RM20]

Close view of the scarp erosion. Note the small tree at the erosion site.

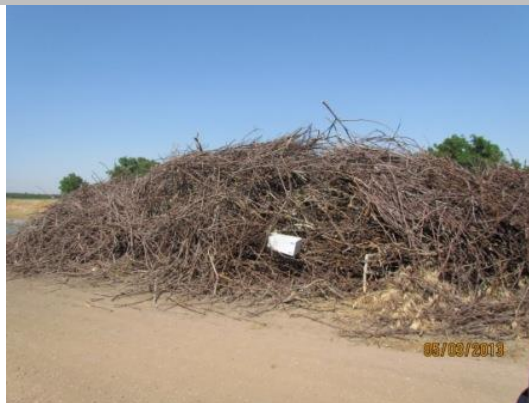
Photo 1 of 1 : SP_2016_NA0017_160_53_20160219_00045.jpg

LM Start	3.41	Rating **	M	Issue No.	53
LM End	3.41	Issue Type +	Ma	Location *	WS
Category	Earthen Levee			GPS Latitude/Longitude	
				Start	End
Item	Encroachments			38.021650 °	38.021650 °
				-121.060312 °	-121.060312 °
DWR ID	DWR_NA0017_16_s_2012_53				
Comment Code					
PR : Prunings					
Inspector Comment					
Burn pile has been burned but new material has been placed.

Prunings were found on the waterside shoulder of the levee looking downstream.

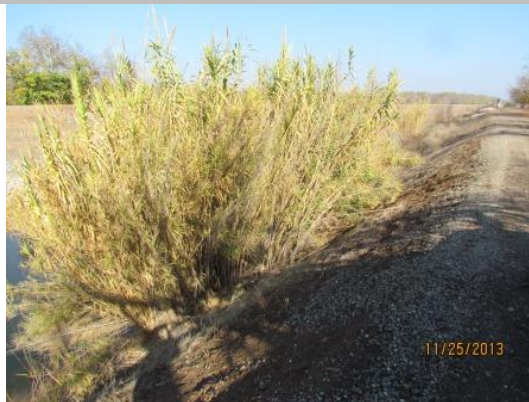
Photo 1 of 1 : SP_2016_NA0017_160_152_20160219_00114.jpg

Arundo was found on the waterside toe of the levee looking upstream.

LM Start	3.48	Rating **	M	Issue No.	152
LM End	3.48	Issue Type +	Ma	Location *	WS
Category	Earthen Levee			GPS Latitude/Longitude	
				Start	End
Item	Vegetation			38.020965 °	38.020965 °
				-121.061215 °	-121.061215 °
DWR ID	DWR_NA0017_16_f_2013_152				
Comment Code					
V2 : Remove the wild growth other than native grasses from the levee slopes.					
Inspector Comment

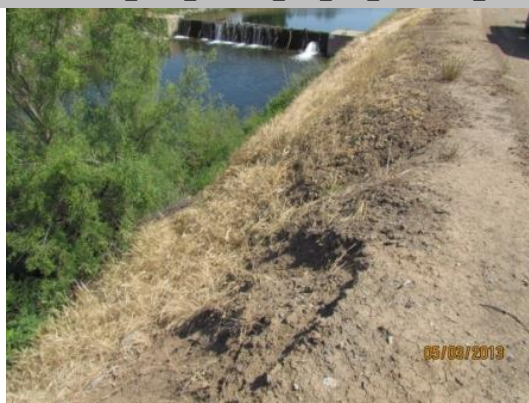
Photo 2 of 2 : SP_2016_NA0017_160_230_20160219_00140.jpg

Erosion was found on the waterside slope of the levee looking upstream.

LM Start	3.53	Rating **	M	Issue No.	230
LM End	3.53	Issue Type +	Ma	Location *	WS
Category	Earthen Levee			GPS Latitude/Longitude	
				Start	End
Item	Erosion / Bank Caving			38.020433 °	38.020433 °
				-121.061867 °	-121.061867 °
DWR ID	DWR_NA0017_16_f_2012_230				
Comment Code					
E2 : Schedule repair of erosion site prior to the next inspection.					
Inspector Comment

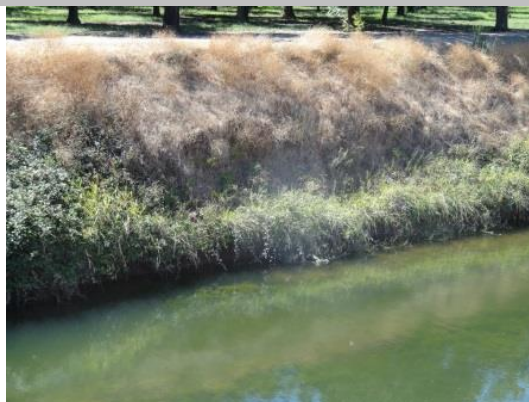
Photo 1 of 2 : SP_2016_NA0017_160_54_20160219_00046.jpg

LM Start	3.61	Rating **	M	Issue No.	54
LM End	3.61	Issue Type +	Ma	Location *	WS
Category	Supplemental			GPS Latitude/Longitude	
				Start	End
Item	DWR Erosion Survey			38.019642 °	38.019642 °
				-121.062917 °	-121.062917 °
DWR ID	DWR_NA0017_16_s_2016_54				
Comment Code					
Inspector Comment					
8/12/2015: No significant change observed.					
8/20/2014: A pocket erosion was found near the water's edge. [2015 Site ID:NA0017U16RM19.29]

Close view of the erosion.

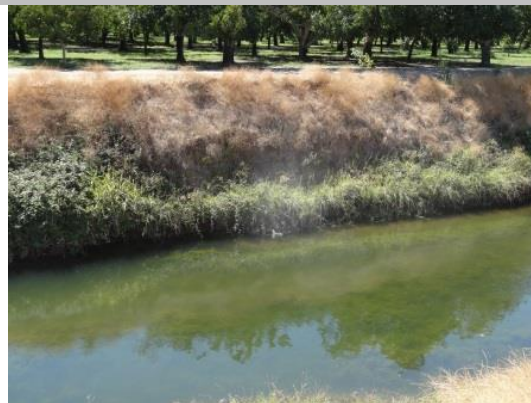
Photo 2 of 2 : SP_2016_NA0017_160_54_20160219_00047.jpg

LM Start	3.61	Rating **	M	Issue No.	54 (cont)	
LM End	3.61	Issue Type +	Ma	Location *	WS	
Category	Supplemental			GPS Latitude/Longitude		
				Start		End
Item	DWR Erosion Survey			38.019642 °	38.019642 °	
				-121.062917 °	-121.062917 °	
DWR ID	DWR_NA0017_16_s_2016_54					
Comment Code						
Inspector Comment						
8/12/2015: No significant change observed.						
8/20/2014: A pocket erosion was found near the water's edge. [2015 Site ID:NA0017U16RM19.29]

View of the site.

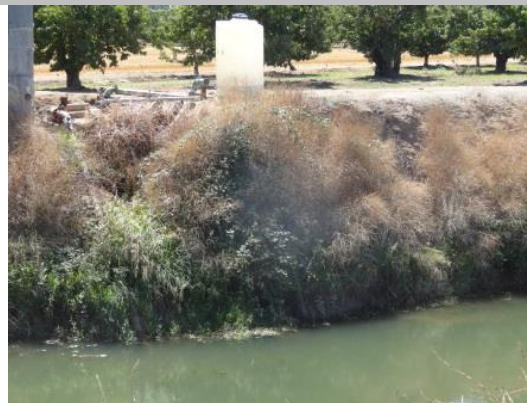
Photo 2 of 2 : SP_2016_NA0017_160_47_20160219_00037.jpg

LM Start	4.16	Rating **	U	Issue No.	47 (cont)	
LM End	4.18	Issue Type +	Ma	Location *	WS	
Category	Supplemental			GPS Latitude/Longitude		
				Start	End	
Item	DWR Erosion Survey			38.012792 °	38.012792 °	
				-121.068073 °	-121.068073 °	
DWR ID	DWR_NA0017_16_s _ 2016_47					
Comment Code						
Inspector Comment						
8/12/2015: No significant change observed.						
8/20/2014: No significant change observed.						
9/12/2013: No significant change observed.						
08/22/2012: An irrigation pipe is present at the site, but probably did not cause the erosion. There is no levee structure on site. The levee crest width and levee height were not measured or estimated in the field.						
[2015 Site ID:NA0017U16RM18.69]

Closer view of the erosion.

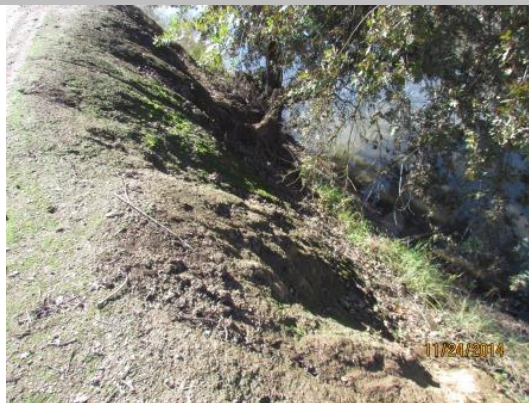
Photo 1 of 2 : SP_2016_NA0017_160_228_20160219_00137.jpg

Updated picture of the slope instability on the waterside of the levee looking downstream.

LM Start	4.20	Rating **	M	Issue No.	228
LM End	4.20	Issue Type +	Ma	Location *	WS
Category	Earthen Levee			GPS Latitude/Longitude	
				Start	End
Item	Slope Stability			38.012288 °	38.012288 °
				-121.068239 °	-121.068239 °
DWR ID	DWR_NA0017_16_f_2012_228				
Comment Code					
S1 : Repair slope instability.					
Inspector Comment

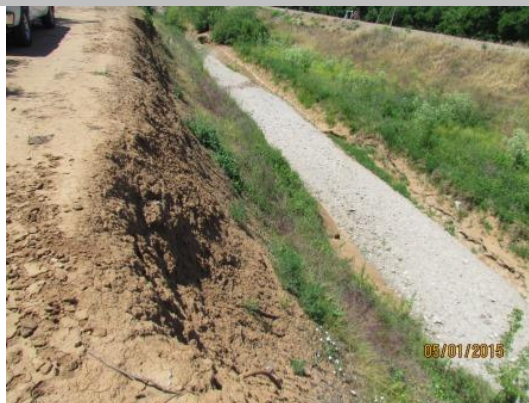
Photo 1 of 1 : SP_2016_NA0017_160_245_20160219_00144.jpg

LM Start	4.85	Rating **	A/W	Issue No.	245
LM End	4.85	Issue Type +	Ma	Location *	WS
Category	Earthen Levee			GPS Latitude/Longitude	
				Start	End
Item	Erosion / Bank Caving			38.003673 °	38.003673 °
				-121.072496 °	-121.072496 °
DWR ID	DWR_NA0017_16_s _ 2015_245				
Comment Code					
E1 : Note and monitor erosion site.					
Inspector Comment					
Observe to make sure the erosion doesn't cut into the access road.

View of erosion on the waterside slope of the levee looking downstream.

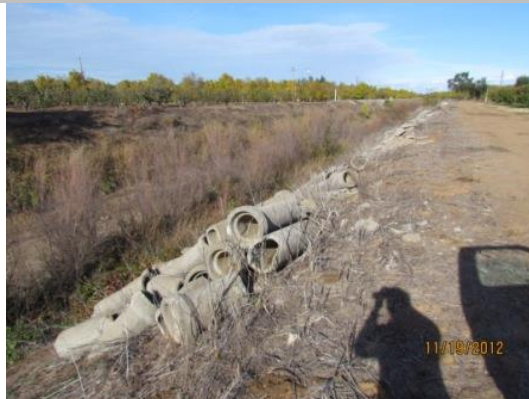
Photo 1 of 2 : SP_2016_NA0017_160_196_20160219_00128.jpg

Concrete debris was found on the waterside slope of the levee looking upstream.

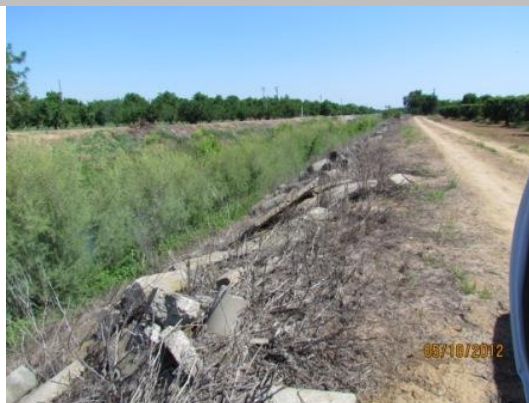
Photo 2 of 2 : SP_2016_NA0017_160_196_20160219_00129.jpg

Debris was found on the waterside of the levee looking upstream.

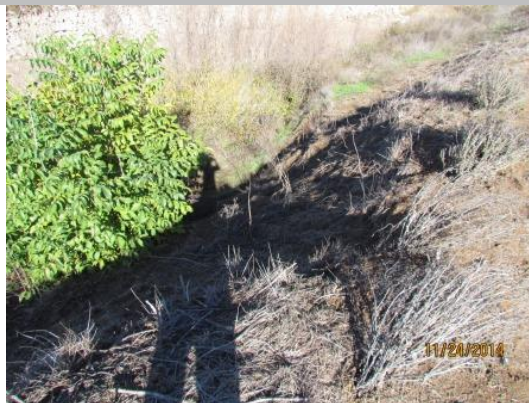
Photo 1 of 1 : SP_2016_NA0017_160_265_20160219_00151.jpg

A slope instability was found on the waterside slope of the levee looking upstream.

LM Start	5.20	Rating **	M	Issue No.	265
LM End	5.20	Issue Type +	Ma	Location *	WS
Category	Earthen Levee			GPS Latitude/Longitude	
				Start	End
Item	Slope Stability			37.999537 °	37.999537 °
				-121.076133 °	-121.076133 °
DWR ID	DWR_NA0017_16_f_2014_265				
Comment Code					
S1 : Repair slope instability.					
Inspector Comment

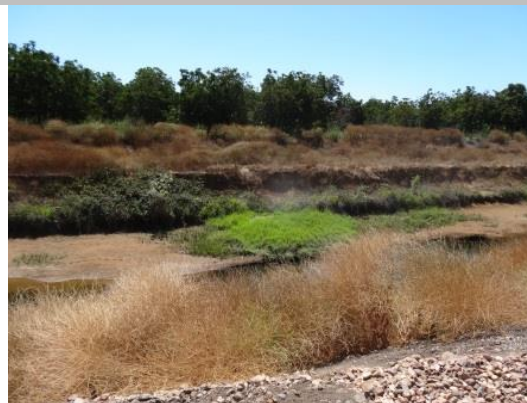
Photo 1 of 2 : SP_2016_NA0017_160_41_20160219_00031.jpg

LM Start	5.33	Rating **	M	Issue No.	41
LM End	5.38	Issue Type +	Ma	Location *	WS
Category	Supplemental			GPS Latitude/Longitude	
				Start	End
Item	DWR Erosion Survey			37.997720 °	37.997720 °
				-121.077807 °	-121.077807 °
DWR ID	DWR_NA0017_16_s_2016_41				
Comment Code					
Inspector Comment					
8/12/2015: No significant change observed.					
8/20/2014: No significant change observed.					
9/12/2013: No significant change observed.					
08/22/2012: The site is located at the opposite river bank of E. Tobacco Road. There is no levee structure on site. The levee crest width and levee height were not measured or estimated in the field. [2015 Site ID:NA0017U16RM17.81]

Front view of the site.

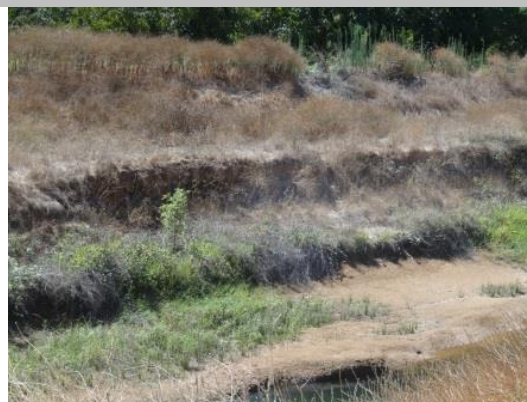
Photo 2 of 2 : SP_2016_NA0017_160_41_20160219_00032.jpg

Close view of the erosion.

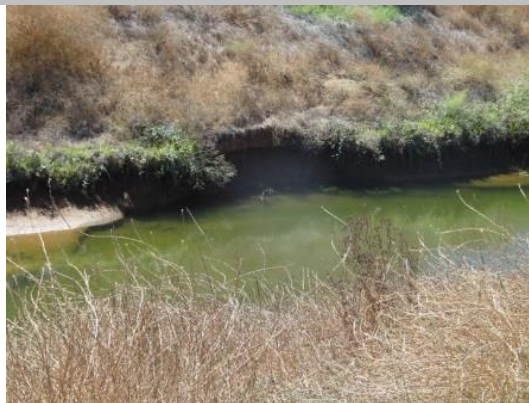
Photo 1 of 3 : SP_2016_NA0017_160_40_20160219_00028.jpg

LM Start	5.56	Rating **	U	Issue No.	40
LM End	5.58	Issue Type +	Ma	Location *	WS
Category	Supplemental			GPS Latitude/Longitude	
				Start	End
Item	DWR Erosion Survey			37.995216°	37.995216°
				-121.080159°	-121.080159°
DWR ID	DWR_NA0017_16_s_2016_40				
Comment Code					
Inspector Comment					
8/12/2015: No significant change observed.					
8/20/2014: No significant change observed.					
9/12/2013: The erosion seems to be caused by high river flow. Dense vegetation is present at the site. Signs of animal activities are visible. There is no levee structure on site. The levee crest width and levee height were not measured or estimated in the field. [2015 Site ID:NA0017U16RM17.27]

Close view of the erosion.

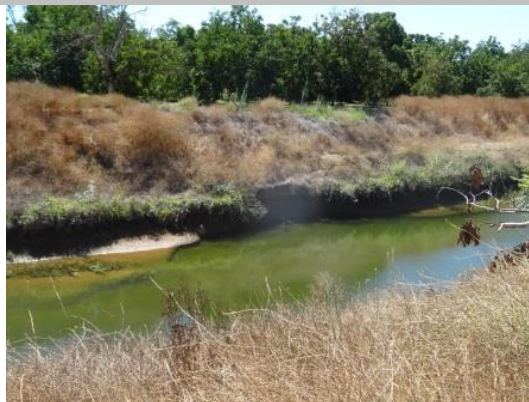
Photo 2 of 3 : SP_2016_NA0017_160_40_20160219_00029.jpg

View from the right river bank.

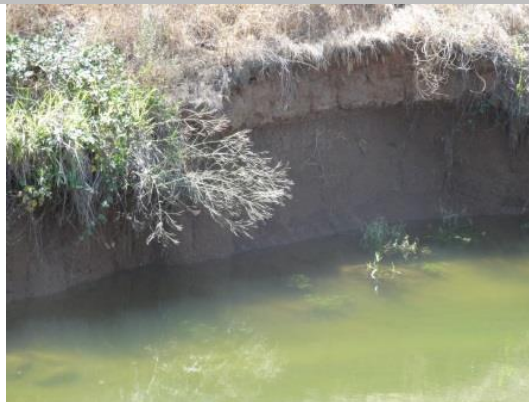
Photo 3 of 3 : SP_2016_NA0017_160_40_20160219_00030.jpg

Close view of the erosion.

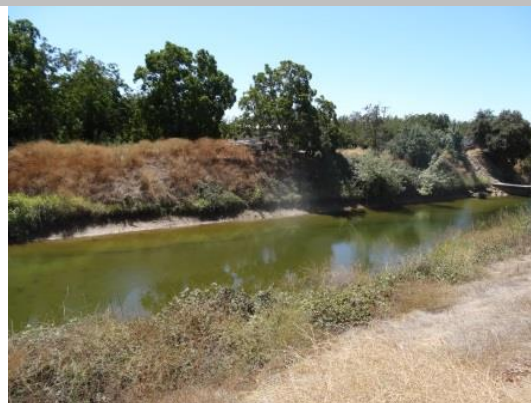
Photo 1 of 2 : SP_2016_NA0017_160_39_20160219_00026.jpg

LM Start	5.71	Rating **	M	Issue No.	39	
LM End	5.72	Issue Type +	Ma	Location *	WS	
Category	Supplemental			GPS Latitude/Longitude		
				Start		End
Item	DWR Erosion Survey			37.993525 °		37.993525 °
				-121.081679 °		-121.081679 °
DWR ID	DWR_NA0017_16_s _ 2016_39					
Comment Code						
Inspector Comment						
8/12/2015: No significant change observed.						
8/20/2014: The erosion is near a tree and probably has been made worse by the unstable bank slope. [2015 Site ID:NA0017U16RM17.11]

View of the site from the right river bank.

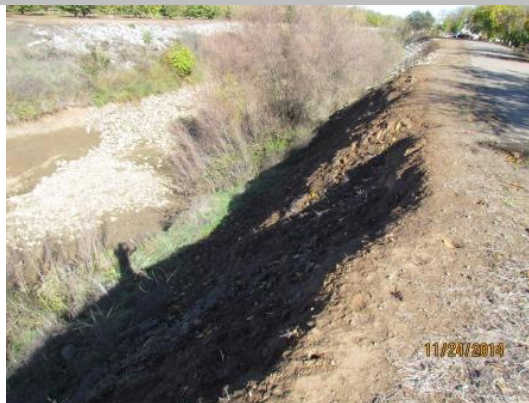
Photo 1 of 1 : SP_2016_NA0017_160_264_20160219_00150.jpg

A slope instability was found on the waterside of the levee looking upstream.

LM Start	5.87	Rating **	M	Issue No.	264
LM End	5.87	Issue Type +	Ma	Location *	WS
Category	Earthen Levee			GPS Latitude/Longitude	
				Start	End
Item	Slope Stability			37.991628 °	37.991628 °
				-121.083312 °	-121.083312 °
DWR ID	DWR_NA0017_16_f_2014_264				
Comment Code					
S1 : Repair slope instability.					
Inspector Comment

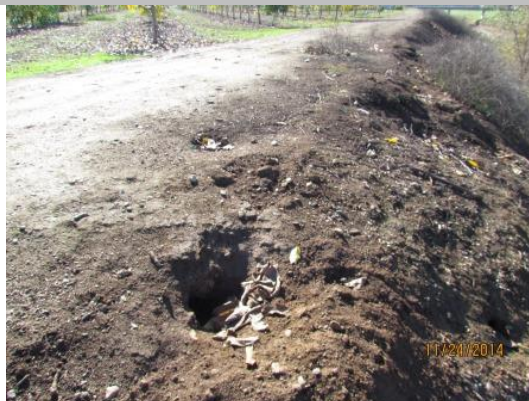
Photo 1 of 2 : SP_2016_NA0017_160_170_20160219_00121.jpg

Updated picture of the rodent holes on the waterside shoulder of the levee looking downstream.

LM Start	6.15	Rating **	M	Issue No.	170
LM End	6.15	Issue Type +	Ma	Location *	WS
Category	Earthen Levee			GPS Latitude/Longitude	
				Start	End
Item	Animal Control			37.988385 °	37.988385 °
				-121.086292 °	-121.086292 °
DWR ID	DWR_NA0017_16_s_2012_170				
Comment Code					
A3 : No rodents visible, but rodent burrows visible; need to backfill and compact or grout burrows.					
Inspector Comment

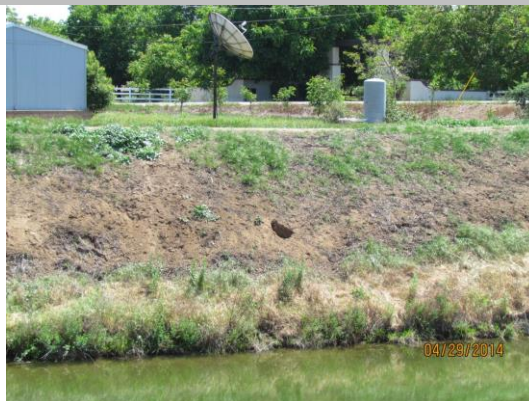
Photo 1 of 1 : SP_2016_NA0017_160_50_20160219_00043.jpg

View of a rodent hole on the waterside slope of the levee. The picture was taken from the opposite side of the levee.

LM Start	6.24	Rating **	M	Issue No.	50
LM End	6.24	Issue Type +	Ma	Location *	WS
Category	Earthen Levee			GPS Latitude/Longitude	
				Start	End
Item	Animal Control			37.987303 °	37.987303 °
				-121.087292 °	-121.087292 °
DWR ID	DWR_NA0017_16_s_2014_50				
Comment Code					
A3 : No rodents visible, but rodent burrows visible; need to backfill and compact or grout burrows.					
Inspector Comment

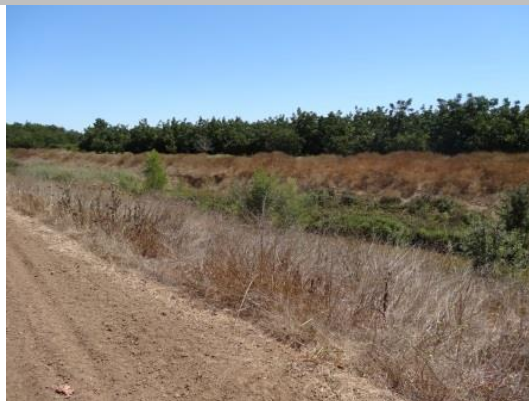
Photo 1 of 3 : SP_2016_NA0017_160_38_20160219_00023.jpg

LM Start	6.49	Rating **	U	Issue No.	38
LM End	6.68	Issue Type +	Ma	Location *	WS
Category	Supplemental			GPS Latitude/Longitude	
				Start	End
Item	DWR Erosion Survey			37.983279 °	37.983279 °
				-121.090843 °	-121.090843 °
DWR ID	DWR_NA0017_16_s_2016_38				
Comment Code					
Inspector Comment					
8/12/2015: No significant change observed.					
8/20/2014: No significant change observed.					
9/12/2013: Site has been surveyed and the erosion has worsened since last year.					
08/22/2012: Discontinuous scarp or pocket erosions occurred along a long stretch of the river, with an erosion height greater than 25 ft. at certain points. There is no levee structure on site. The levee crest width and levee height were not measured or estimated in the field. [2015 Site ID:NA0017U16RM16.27]

Downstream view of the site from the right river bank.

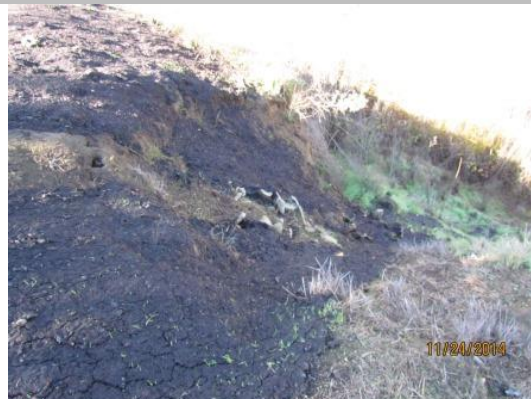
Photo 1 of 2 : SP_2016_NA0017_160_120_20160219_00097.jpg

LM Start	6.70	Rating **	M	Issue No.	120
LM End	6.70	Issue Type +	Ma	Location *	WS
Category	Earthen Levee			GPS Latitude/Longitude	
				Start	End
Item	Slope Stability			37.982299 °	37.982299 °
				-121.092665 °	-121.092665 °
DWR ID	DWR_NA0017_16_s _ 2014_120				
Comment Code					
S1 : Repair slope instability.					
Inspector Comment

Updated picture of the slope instability on the waterside of the levee looking downstream.

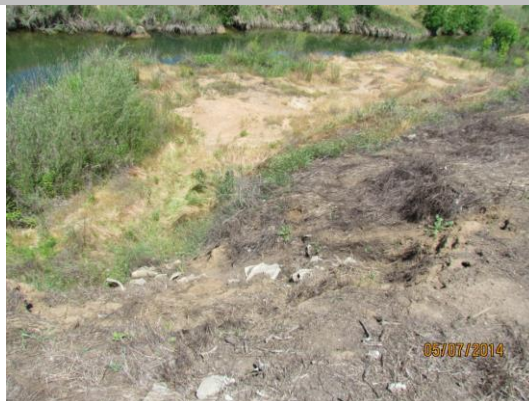
Photo 2 of 2 : SP_2016_NA0017_160_120_20160219_00098.jpg

Slope instability was found on the waterside of the levee looking upstream.

LM Start	6.70	Rating **	M	Issue No.	120 (cont)	
LM End	6.70	Issue Type +	Ma	Location *	WS	
Category	Earthen Levee			GPS Latitude/Longitude		
				Start		End
Item	Slope Stability			37.982299 °		37.982299 °
				-121.092665 °		-121.092665 °
DWR ID	DWR_NA0017_16_s_2014_120					
Comment Code						
S1 : Repair slope instability.						
Inspector Comment

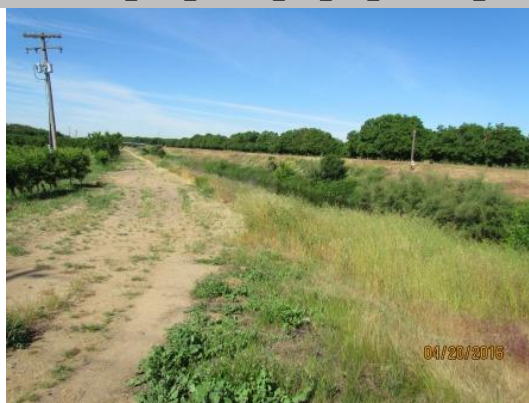
Photo 1 of 1 : SP_2016_NA0017_160_272_20160427_00368.jpg

LM Start	6.88	Rating **	M	Issue No.	272
LM End	7.13	Issue Type +	Ma	Location *	WS
Category	Earthen Levee			GPS Latitude/Longitude	
				Start	End
Item	Vegetation			37.980975 °	37.979139 °
				-121.094914 °	-121.098858 °
DWR ID	DWR_NA0017_16_s_2016_272				
Comment Code					
V1 : Control annual grass and weeds on the levee slopes and easements.					
Inspector Comment

View of the vegetation on the waterside of the levee.

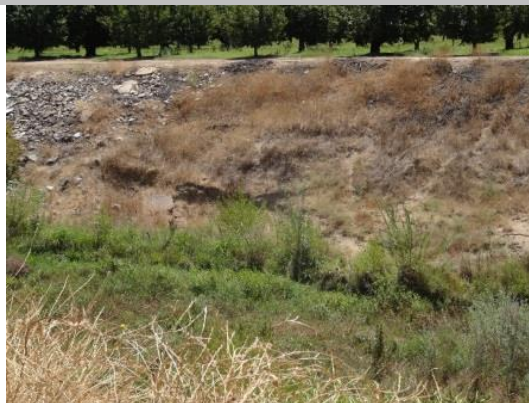
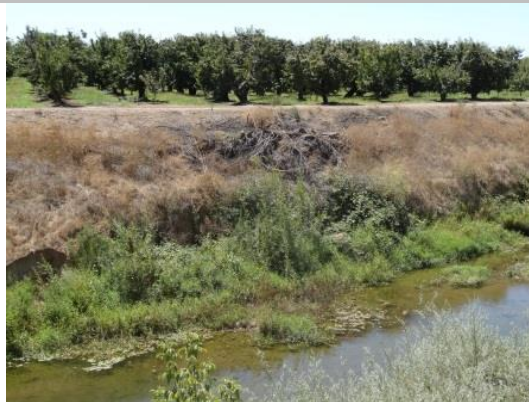
LM Start	7.27	Rating **	U	Issue No.	37
LM End	7.33	Issue Type +	Ma	Location *	WS
Category	Supplemental			GPS Latitude/Longitude	
				Start	End
Item	DWR Erosion Survey			37.978194 °	37.978194 °
				-121.101696 °	-121.101696 °
DWR ID	DWR_NA0017_16_s _ 2016_37				
Comment Code					
Inspector Comment					
8/12/2015: No significant change observed.					
8/20/2014: No significant change observed. Note the site ID changed from NA0017U16RM10.82 to NA0017U16RM15.57 to reflect the correct river mile.					
09/12/2013: The site is located at immediately downstream of a levee segment protected by broken concrete. There is no levee structure on site. The levee crest width and levee height were not measured or estimated in the field. [2015 Site ID:NA0017U16RM15.57]

Close view of the erosion.

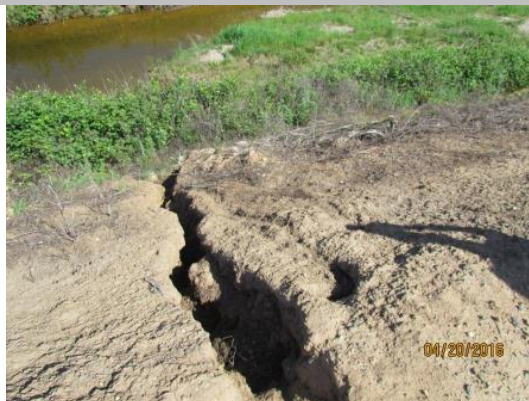
Photo 1 of 2 : SP_2016_NA0017_160_246_20160427_00369.jpg

LM Start	7.39	Rating **	M	Issue No.	246
LM End	7.39	Issue Type +	Ma	Location *	WS
Category	Earthen Levee			GPS Latitude/Longitude	
				Start	End
Item	Erosion / Bank Caving			37.977610 °	37.977610 °
				-121.103159 °	-121.103159 °
DWR ID	DWR_NA0017_16_s_2015_246				
Comment Code					
E1 : Note and monitor erosion site.					
Inspector Comment

Updated picture of the erosion on the waterside shoulder of the levee during spring 2016 inspection.

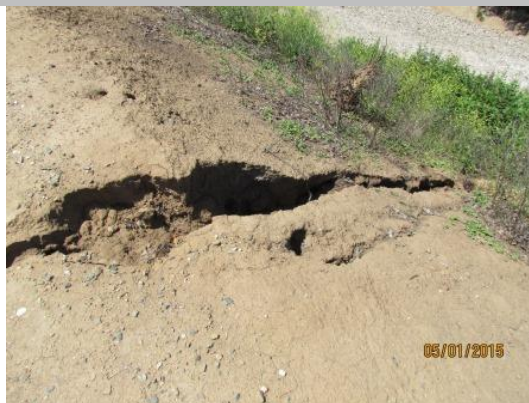
Photo 2 of 2 : SP_2016_NA0017_160_246_20160219_00145.jpg

Erosion was found on the waterside shoulder of the levee looking downstream.

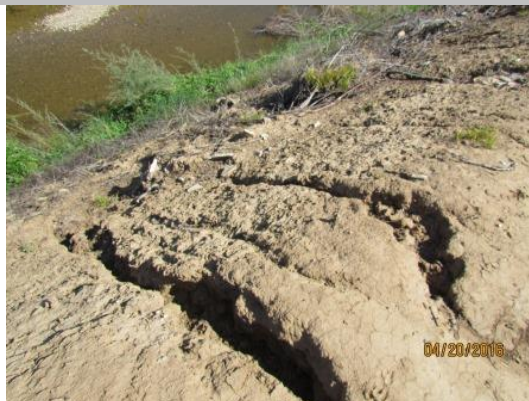
Photo 1 of 2 : SP_2016_NA0017_160_237_20160427_00370.jpg

LM Start	7.42	Rating **	M	Issue No.	237
LM End	7.42	Issue Type +	Ma	Location *	WS
Category	Earthen Levee			GPS Latitude/Longitude	
				Start	End
Item	Erosion / Bank Caving			37.977421 °	37.977421 °
				-121.103507 °	-121.103507 °
DWR ID	DWR_NA0017_16_f_2015_237				
Comment Code					
E2 : Schedule repair of erosion site prior to the next inspection.					
Inspector Comment

Updated picture of the erosion on the waterside shoulder of the levee during spring 2016 inspection.

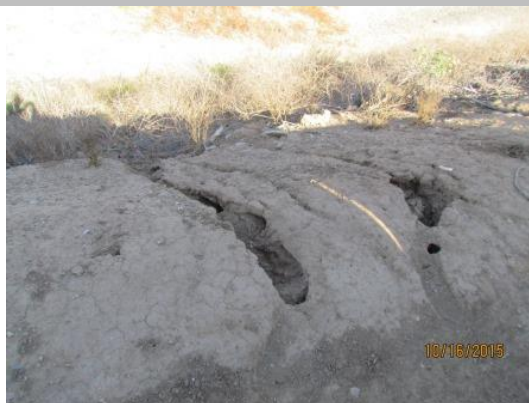
Photo 2 of 2 : SP_2016_NA0017_160_237_20160219_00143.jpg

Erosion caused by runoff was found on the waterside shoulder of the levee.

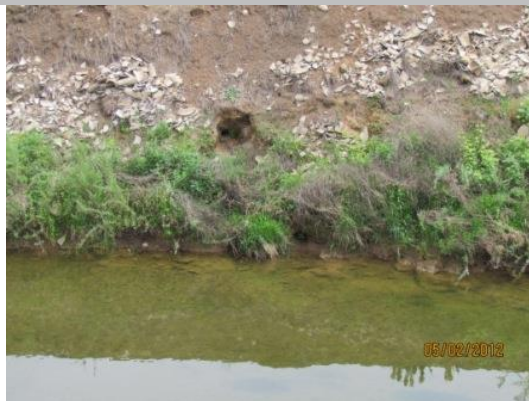
Photo 1 of 1 : SP_2016_NA0017_160_218_20160219_00136.jpg

LM Start	7.57	Rating **	M	Issue No.	218
LM End	7.57	Issue Type +	Ma	Location *	WS
Category	Earthen Levee			GPS Latitude/Longitude	
				Start	End
Item	Animal Control			37.976122 °	37.976122 °
				-121.105791 °	-121.105791 °
DWR ID	DWR_NA0017_16_s_2012_218				
Comment Code					
A3 : No rodents visible, but rodent burrows visible; need to backfill and compact or grout burrows.					
Inspector Comment

A possible beaver den was found on waterside slope of the levee. The picture was taken from the opposite bank of the levee.

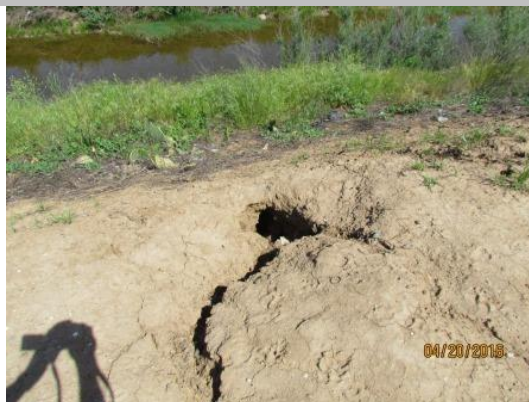
Photo 1 of 1 : SP_2016_NA0017_160_275_20160427_00371.jpg

LM Start	7.84	Rating **	M	Issue No.	275
LM End	7.84	Issue Type +	Ma	Location *	WS
Category	Earthen Levee			GPS Latitude/Longitude	
				Start	End
Item	Animal Control			37.973620 °	37.973620 °
				-121.109680 °	-121.109680 °
DWR ID	DWR_NA0017_16_s_2016_275				
Comment Code					
A3 : No rodents visible, but rodent burrows visible; need to backfill and compact or grout burrows.					
Inspector Comment

View of a rodent hole on the waterside shoulder of the levee.

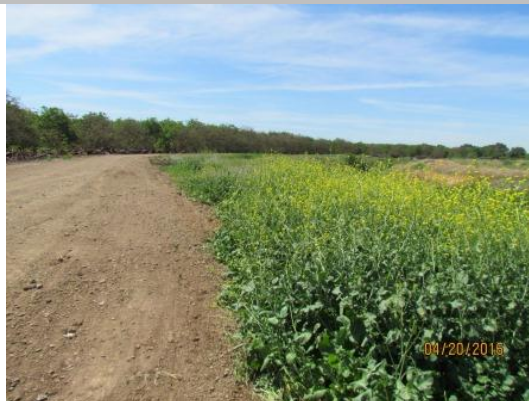
Photo 1 of 1 : SP_2016_NA0017_160_276_20160427_00372.jpg

LM Start	8.08	Rating **	M	Issue No.	276
LM End	9.05	Issue Type +	Ma	Location *	WS
Category	Earthen Levee			GPS Latitude/Longitude	
				Start	End
Item	Vegetation			37.971593 °	37.966713 °
				-121.113017 °	-121.128226 °
DWR ID	DWR_NA0017_16_s _ 2016_276				
Comment Code					
V1 : Control annual grass and weeds on the levee slopes and easements.					
Inspector Comment

View of the vegetation on the waterside of the levee looking downstream.

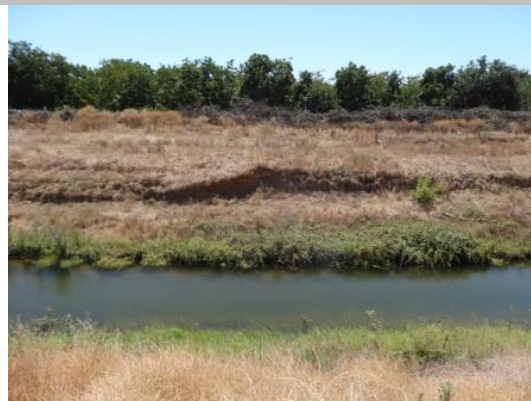
Photo 1 of 2 : SP_2016_NA0017_160_36_20160219_00019.jpg

LM Start	8.34	Rating **	M	Issue No.	36
LM End	8.38	Issue Type +	Ma	Location *	WS
Category	Supplemental			GPS Latitude/Longitude	
				Start	End
Item	DWR Erosion Survey			37.969213 °	37.969213 °
				-121.116574 °	-121.116574 °
DWR ID	DWR_NA0017_16_s_2016_36				
Comment Code					
Inspector Comment					
8/12/2015: No significant change observed. 8/20/2014: No significant change observed. 9/12/2013: No significant change observed. 08/22/2012: The erosion occurred on a berm of approximately 25 ft. wide. Site is covered with dense vegetation. There is no levee structure on site. The levee crest width and levee height were not measured or estimated in the field. [2015 Site ID:NA0017U16RM14.48]

View of the site from the right river bank.

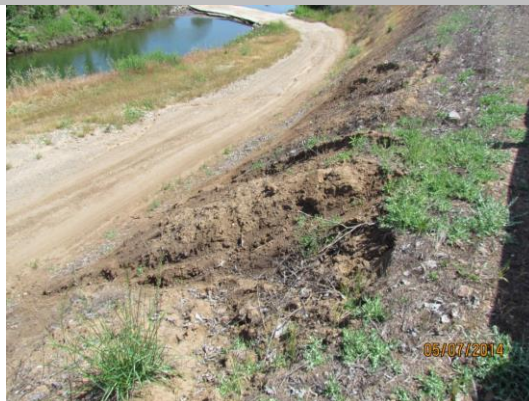
Photo 1 of 2 : SP_2016_NA0017_160_128_20160219_00102.jpg

LM Start	8.60	Rating **	M	Issue No.	128
LM End	8.60	Issue Type +	Ma	Location *	WS
Category	Earthen Levee			GPS Latitude/Longitude	
				Start	End
Item	Slope Stability			37.968157 °	37.968157 °
				-121.120620 °	-121.120620 °
DWR ID	DWR_NA0017_16_s_2013_128				
Comment Code					
S1 : Repair slope instability.					
Inspector Comment

Updated picture of the slope instability on the waterside of the levee looking upstream during spring 2014 inspection.

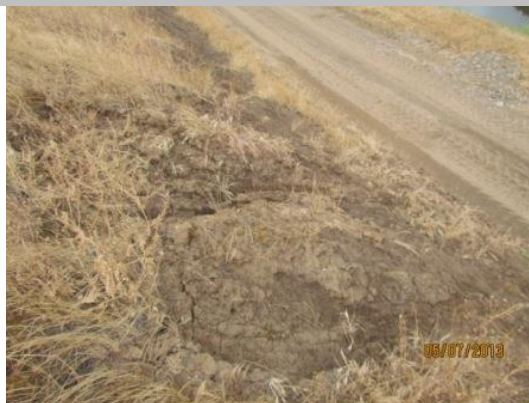
Photo 2 of 2 : SP_2016_NA0017_160_128_20160219_00103.jpg

Slope instability was found on the waterside slope of the levee looking downstream.

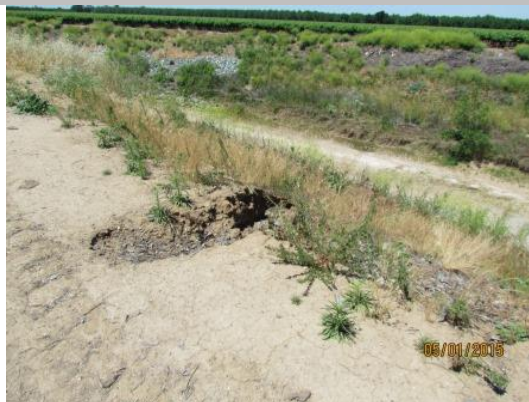
Photo 1 of 1 : SP_2016_NA0017_160_248_20160219_00146.jpg

LM Start	8.68	Rating **	M	Issue No.	248
LM End	8.68	Issue Type +	Ma	Location *	WS
Category	Earthen Levee			GPS Latitude/Longitude	
				Start	End
Item	Erosion / Bank Caving			37.968169 °	37.968169 °
				-121.122047 °	-121.122047 °
DWR ID	DWR_NA0017_16_s_2015_248				
Comment Code					
E1 : Note and monitor erosion site.					
Inspector Comment					
Runoff

Erosion was found on the waterside looking downstream.

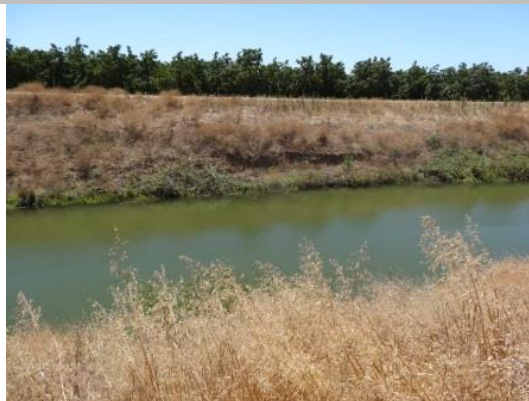
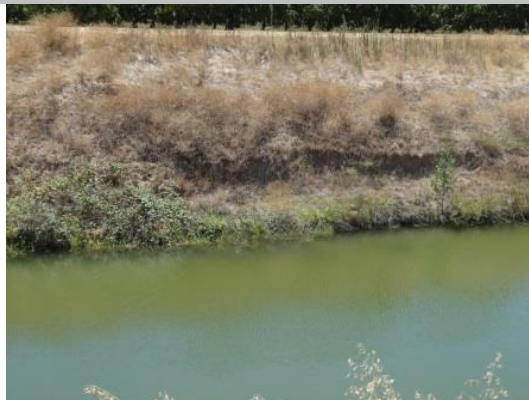
LM Start	9.00	Rating **	M	Issue No.	18
LM End	9.00	Issue Type +	Ma	Location *	WS
Category	Supplemental			GPS Latitude/Longitude	
				Start	End
Item	DWR Erosion Survey			37.966615 °	37.966615 °
				-121.127328 °	-121.127328 °
DWR ID	DWR_NA0017_16_s_2016_18				
Comment Code					
Inspector Comment					
8/12/2015: No significant change observed.					
8/20/2014: No significant change observed.					
9/12/2013: No significant change observed.					
08/22/2012: Pocket erosion at the levee toe and slope. The erosion is covered with dense vegetation. There is no levee structure on site. The levee crest width and levee height were not measured or estimated in the field. [2015 Site ID:NA0017U16RM13.86]

Front view of the erosion.

Closer view of the erosion.

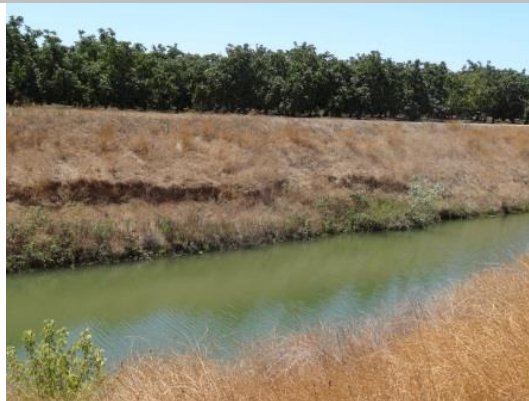
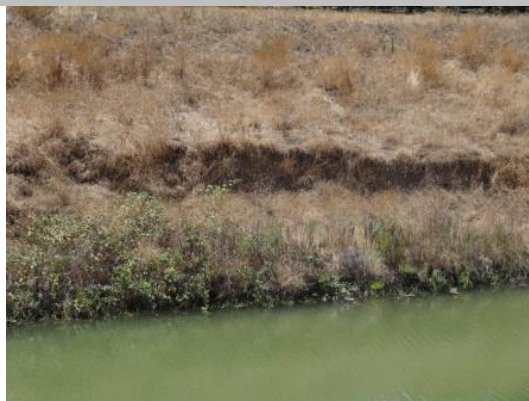
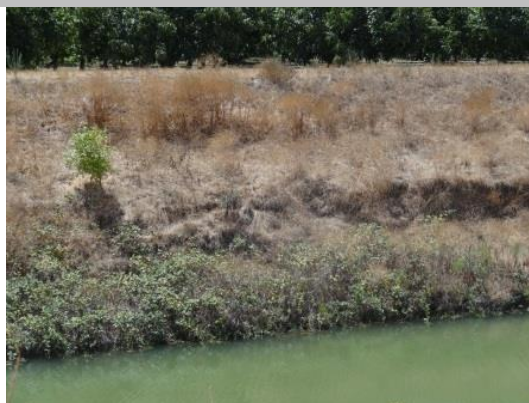
LM Start	9.11	Rating **	M	Issue No.	14
LM End	9.13	Issue Type +	Ma	Location *	WS
Category	Supplemental			GPS Latitude/Longitude	
				Start	End
Item	DWR Erosion Survey			37.966922 °	37.966922 °
				-121.129533 °	-121.129533 °
DWR ID	DWR_NA0017_16_s_2016_14				
Comment Code					
Inspector Comment					
8/12/2015: No significant change observed.					
8/20/2014: No significant change observed.					
9/12/2013: No significant change observed.					
08/22/2012: The erosion is covered with dense vegetation. There is no levee structure on site. The levee crest width and levee height were not measured or estimated in the field. [2015 Site ID:NA0017U16RM13.72]

Close view of the erosion.

Front view of the erosion.

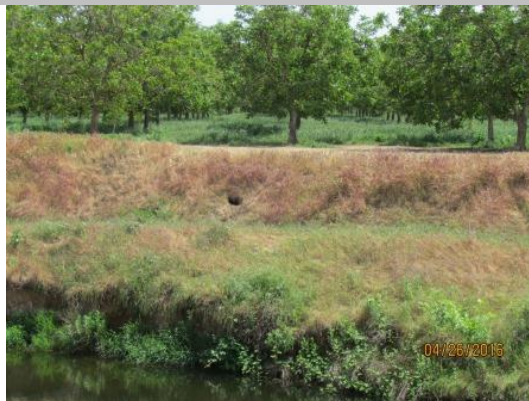
Photo 1 of 1 : SP_2016_NA0017_160_304_20160429_00385.jpg

LM Start	9.33	Rating **	U	Issue No.	304
LM End	9.33	Issue Type +	Ma	Location *	WS
Category	Earthen Levee			GPS Latitude/Longitude	
				Start	End
Item	Animal Control			37.966739 °	37.966739 °
				-121.133254 °	-121.133254 °
DWR ID	DWR_NA0017_16_s_2016_304				
Comment Code					
A3 : No rodents visible, but rodent burrows visible; need to backfill and compact or grout burrows.					
Inspector Comment

View of a rodent hole possible made by a coyote on the waterside slope of the levee. The picture was taken from the opposite side of the levee.

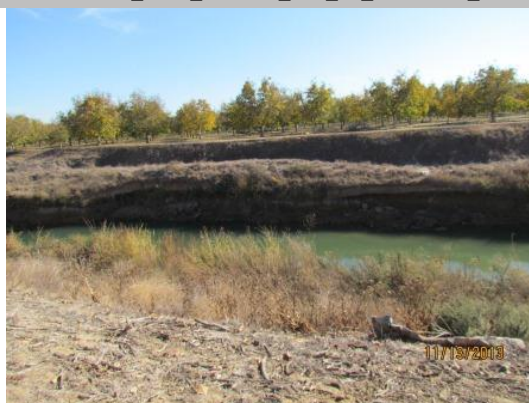
Photo 1 of 1 : SP_2016_NA0017_160_28_20160219_00017.jpg

LM Start	9.48	Rating **	M	Issue No.	28
LM End	9.48	Issue Type +	Ma	Location *	WS
Category	Earthen Levee			GPS Latitude/Longitude	
				Start	End
Item	Erosion / Bank Caving			37.966239 °	37.966239 °
				-121.136172 °	-121.136172 °
DWR ID	DWR_NA0017_16_f_2013_28				
Comment Code					
E2 : Schedule repair of erosion site prior to the next inspection.					
Inspector Comment					
Erosion was found on the waterside toe of the levee.

View of the erosion on the waterside toe of the levee looking from the opposite side of the levee.

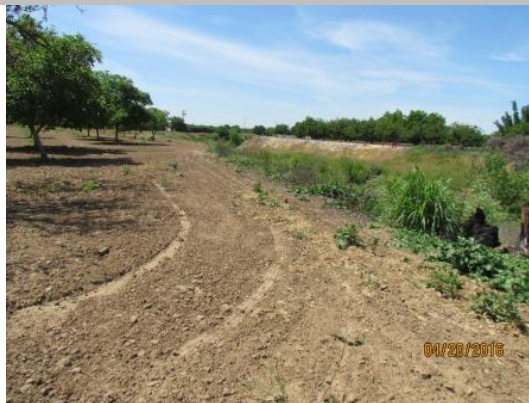
Photo 1 of 1 : SP_2016_NA0017_160_283_20160427_00374.jpg

LM Start	10.75	Rating **	M	Issue No.	283
LM End	10.87	Issue Type +	Ma	Location *	CR
Category	Earthen Levee			GPS Latitude/Longitude	
				Start	End
Item	Crown Surface / Depressions / Rutting			37.962547 °	37.961495 °
				-121.158101 °	-121.159824 °
DWR ID	DWR_NA0017_16_s_2016_283				
Comment Code					
C3 : Add appropriate gravel or road base. Grade and compact.					
Inspector Comment					
Farmer took away the levee access road.

Farmer removed the levee patrol road. The picture was taken from the crown looking downstream.
